# Manhole Inspection Summary

Manhole # S17EE2038MH

Insp Date: **10/2/06 2:51 PM**

**Location** Address: **1716 SULGRAVE AVE**

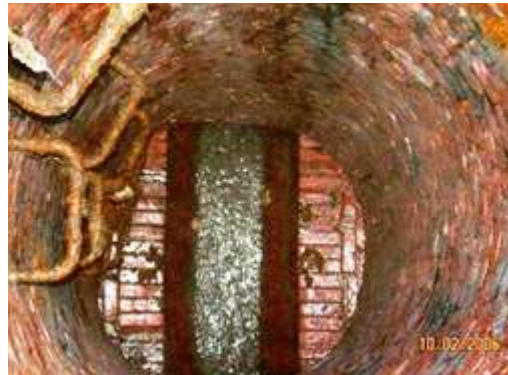
Top View

**Steps** Count: **10** Missing: **0** ☒ **Corroded**

**Surcharge** ☒ **Evidence Of Surcharge** Depth: **8** (ft.) ☐ Active Surcharge Present

Corroded steps. Evidence of surcharge.

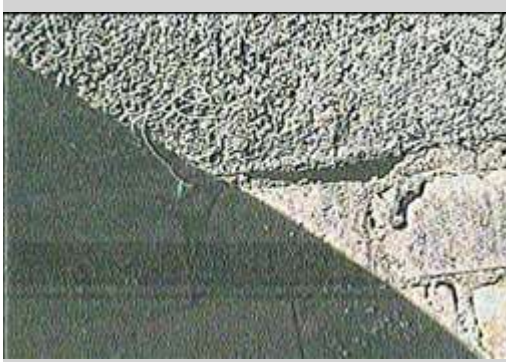
Defect

Infiltration: ☐ None ☒ **Joint** ☐ Cracks ☒ **Mortar** ☐ Roots ☐ Wall

Adjustment infiltration.

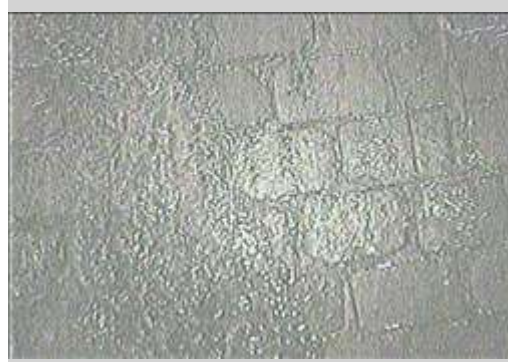
Defect

Infiltration: ☐ None ☐ Joint ☐ Cracks ☒ **Mortar** ☐ Roots ☒ **Wall**

Barrel infiltration.

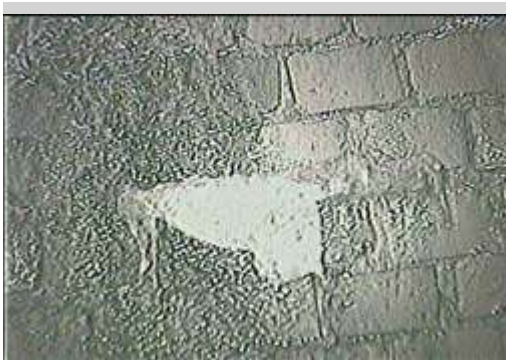
Defect

Evidence of surcharge.

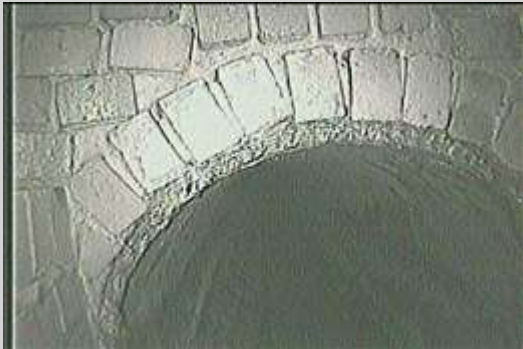
### 24 in. Circular Gravity Sewer Pipe Out @ 12 O'Clock

Infiltration: **Evidence** Pipe Seal Cond: **Unknown**

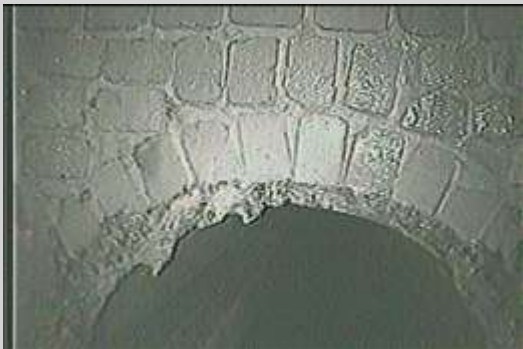
### 24 in. Circular Gravity Sewer Pipe In @ 6 O'Clock

Infiltration: **Evidence** Pipe Seal Cond: **Roots**
